G8813.04-303-11-R0
ACOUSTICAL PERFORMANCE TEST REPORT
ASTM E90

NEON ENERGY

Series/Model: ULTRA

Type: Horizontal Sliding Window

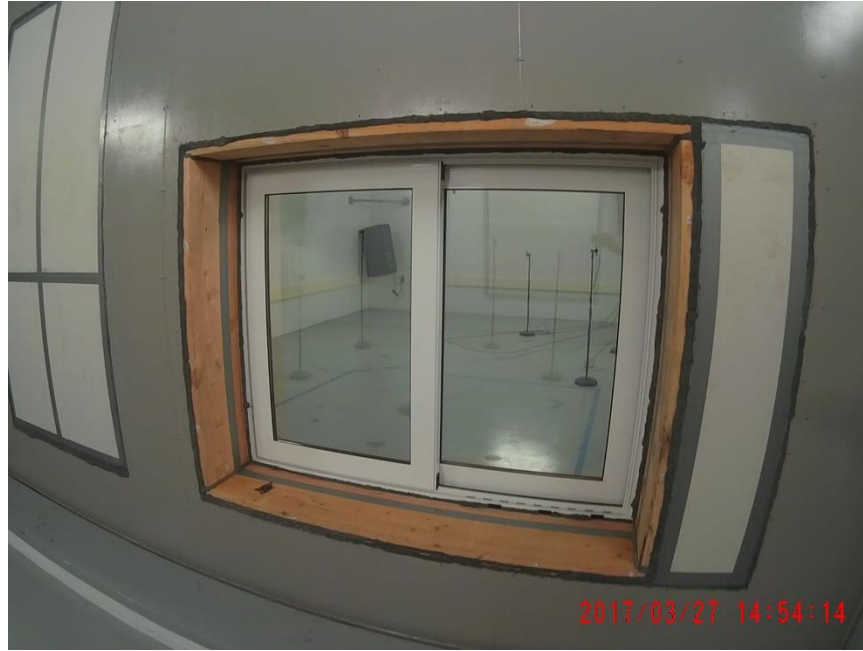
Source Room View of Test Specimen
